Water and Heritage management; Experiences gained at Bryggen in Bergen, Norway

Sustainable urban water planning through multi-benefits

Ann Christensson, Hans de Beer and Tone Muthanna

SKINT Final Conference, September 18, 2012

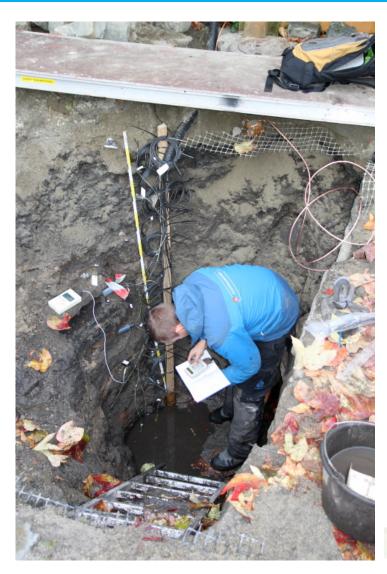
Installation of sensors in test-pit

Monitoring in the unsaturated zone

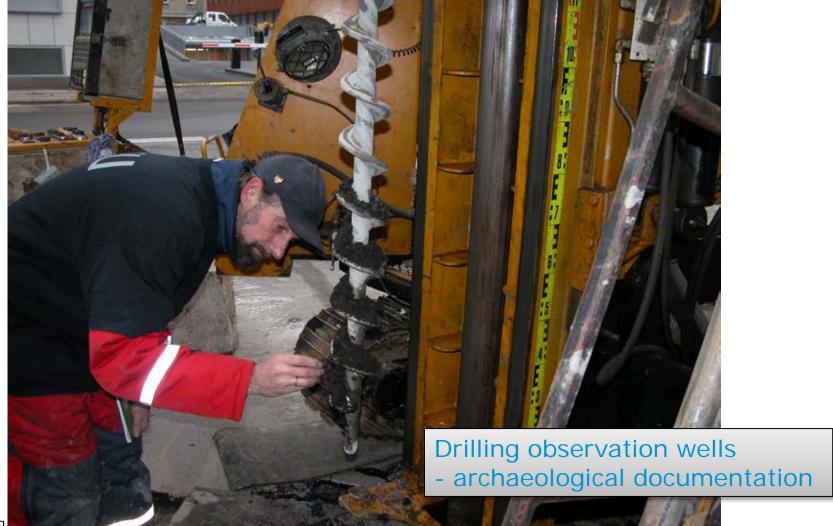
Drilling of dipwells Monitoring the saturated zone

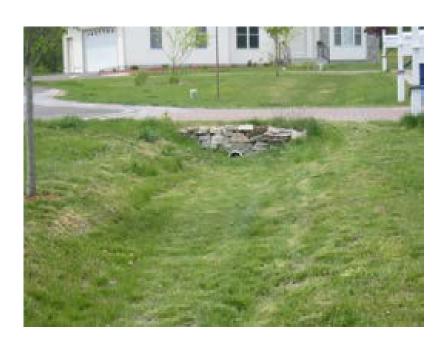
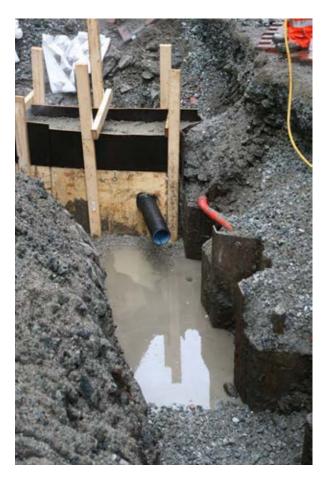
Mitigation measures implemented at Bryggen

- Raising of drainage outflow level under the Radisson Blu Royal Hotel.
- Construction of 5 bentonite dams at points along the sheet piling running along the Bredsgården tenement in order to hold back rainwater as a contribution to the replenishment of the water-table.

- Construction of swales and installation of storage facilities for collection and infiltration of water into the cultural deposits.
- Plugging of anchor stay holes and other leakage points in the sheet piling.

- Replacement of permeable soil with materials such as woodchips or clay.
- The effect of the measures is monitored continuously by means of sensors and other devices (some telemetry is now online to provide real-time data).

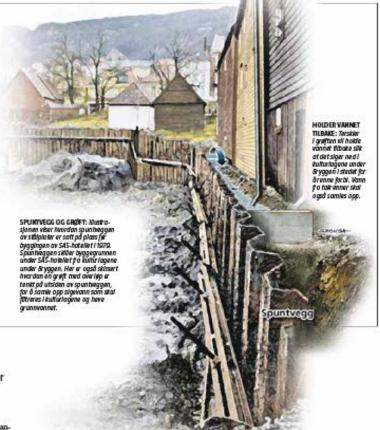
SEGET: Catedokket i Bugården var likke skjevt da det ble lagt i forbindelse med byggingen av SAS-hotellet for vel 30 år slåen. I dag ser vi tydelig hvordan dekket heller kraftig ned mot Bryggen. Spunt-veggen av ståbljelser som avstiver byggegrunnen under SAS-hotellet forløper gjennom Bugården (se star Mustrasjon).

Det meste av regnet som faller over Bryggen renner vekk over brostein og gjennom avløp. Nå skal det ledes dit Bryggen trenger det, i undergrunnen.

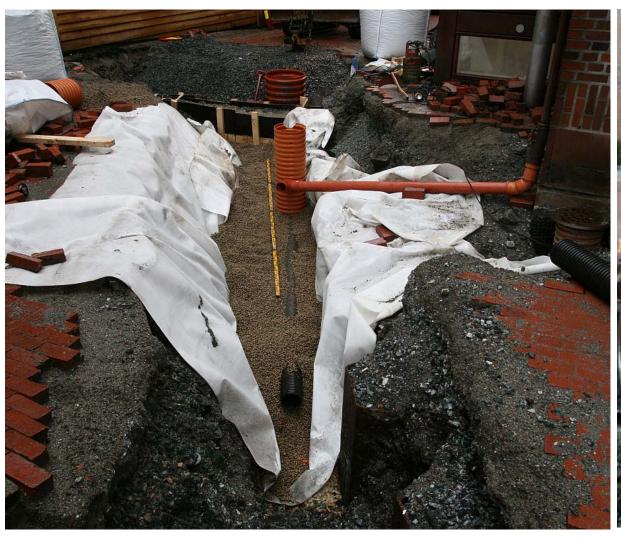
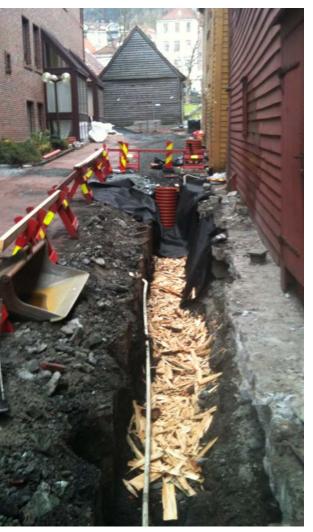
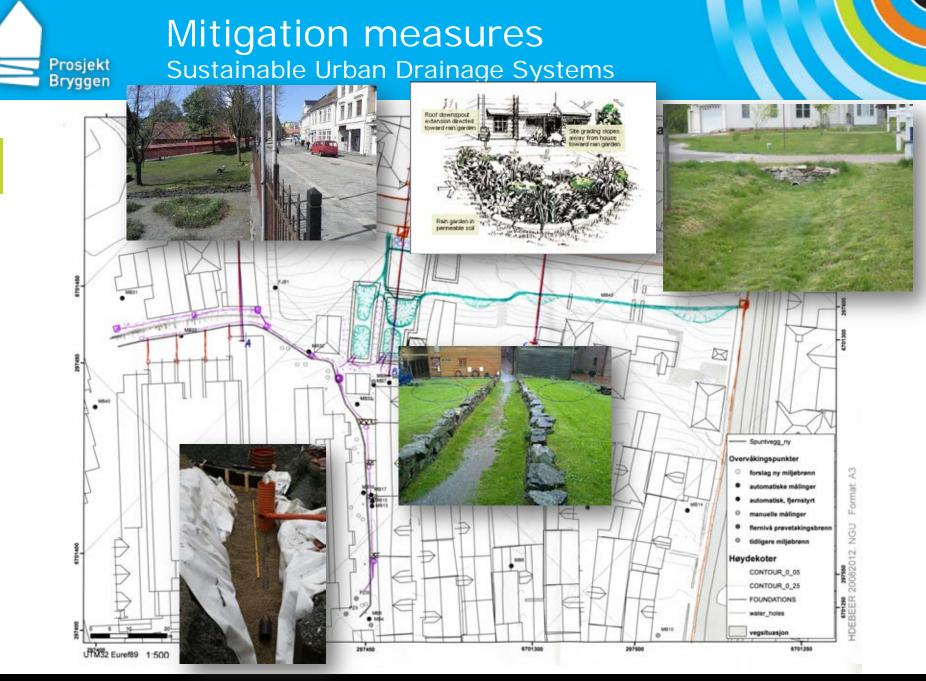
Mitigation measures Stepwise infiltration facility
